Manhole Inspection Summary

Manhole # S35C__051MH

Insp Date: **8/5/08 8:05 AM**

Location Address: **side 323 n charles st**

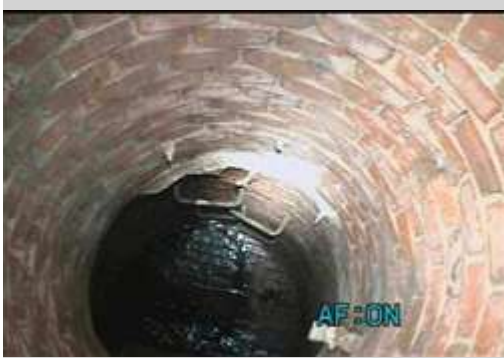
Defect 2

Steps Count: **6** Missing: **2** ☒ **Corroded**

steps missing/corroded

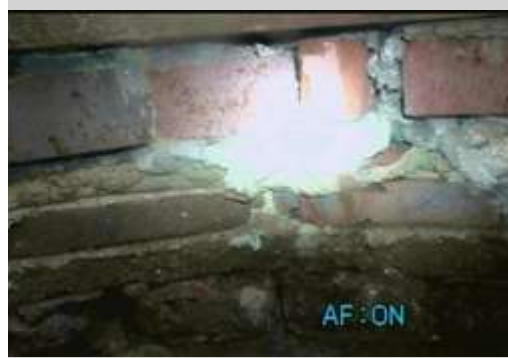
Defect 1

Condition: ☐ Sound ☐ Cracked ☐ Root Intrusion ☒ **Loose Brick** ☒ **Deteriorated**

chimney loose bricks, deteriorated

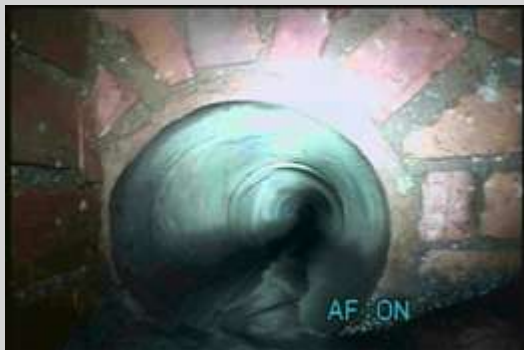
12 O'Clock Outflow

8 in. Circular Gravity Sewer
Pipe Out @ 12 OClock

Infiltration: None Pipe Seal Cond: Unknown

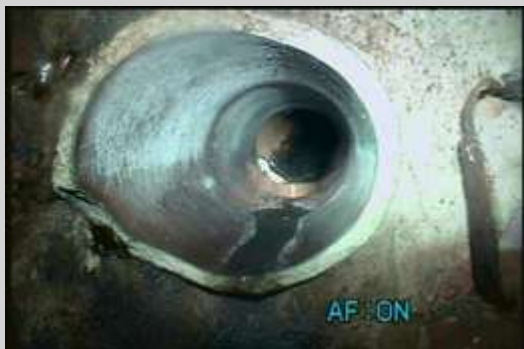
3 O'Clock Inflow

8 in. Circular Gravity Sewer
Pipe In @ 3 OClock

Drop: Outside Direct

Drop Condition: Open
